Xbox One Teardown

Xbox One teardown on November 21, 2013.

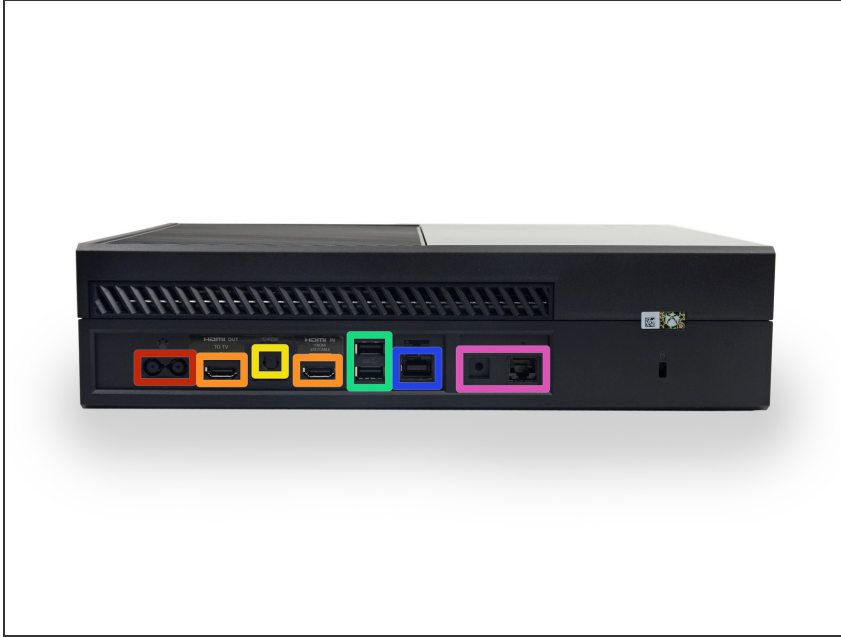
Step 4

- 'Round the back of the console, itself, we find:
 - Power Inlet
 - HDMI Out (left) and HDMI In (right)
 - Digital Optical Audio Out
 - Two USB 3.0 Ports
 - Kinect Port
 - Infrared Output and Ethernet Port
- Possibly up to no good is a roguish third USB 3.0 port, manning the left side all by itself.

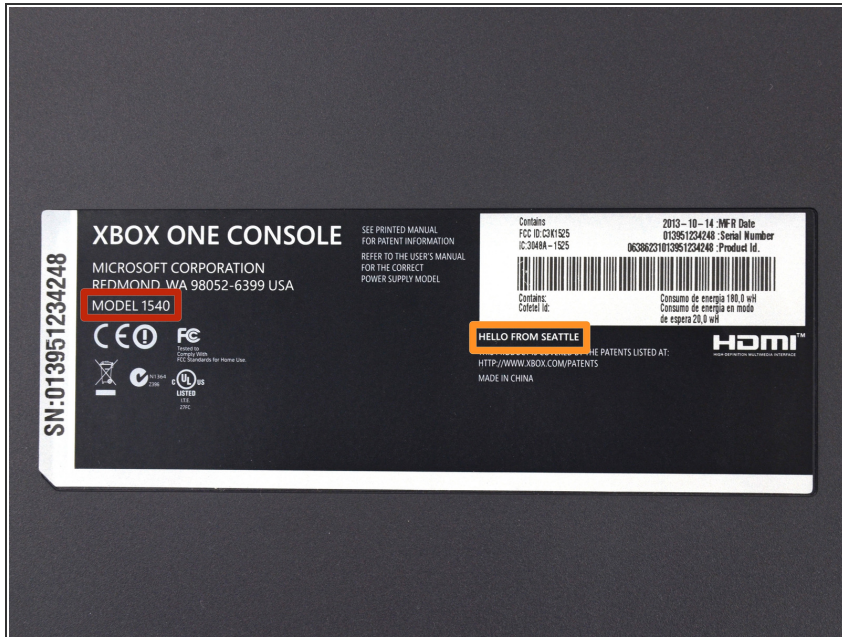
Step 5

- Making our way to the bottom, we check the tags to find...power ratings in Spanish?
- *i* El Xbox One consume 180 Wh de energia y en modo de espera consume 20 Wh.
- The Xbox One is identified as model 1540 and was designed by the Microsoft Corporation in Redmond, WA.
- Our Xbox One was manufactured on October 14, 2013 in China.
- And, in friendly words across the back, Microsoft says "Hello From Seattle."

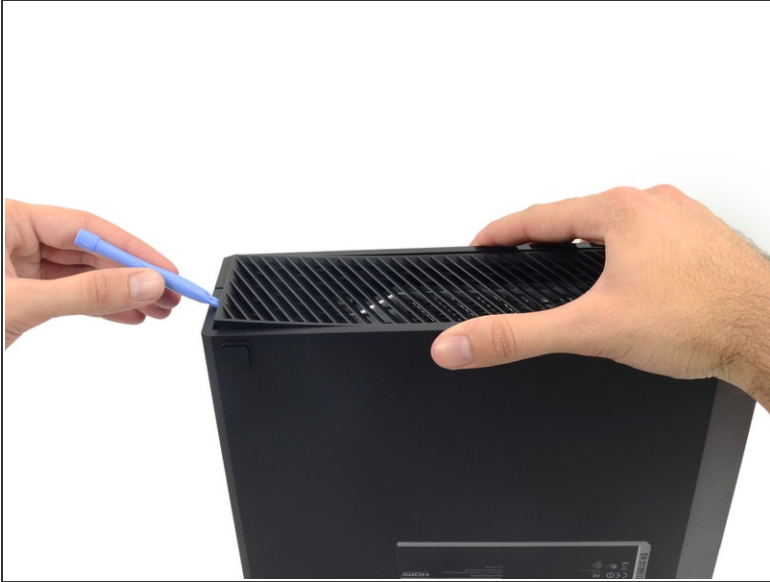
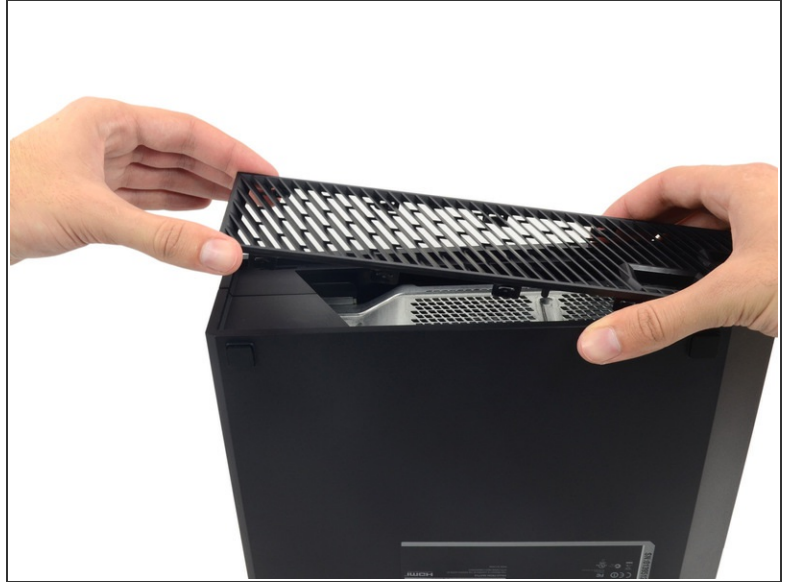
Step 7

- [Don't panic](#); we're prepared.
- Despite the lack of screws, we find a way in with a plastic opening tool—prying the grille up.
- i This is similar to the [Bottom Vent](#) disassembly procedure in the Xbox 360.

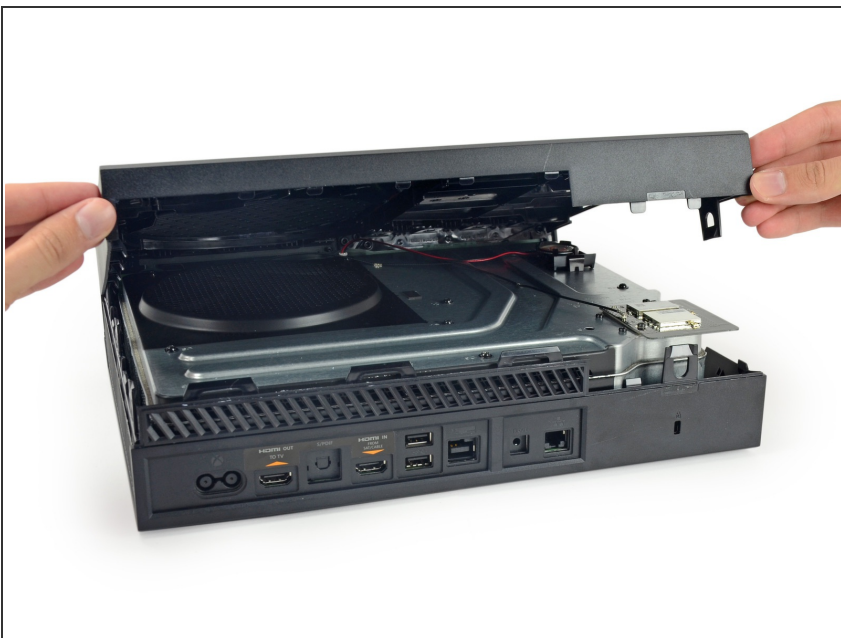
Step 8

- *Speak, friend, and enter.* Giving the right password and freeing some clips, we gain access to the innards of the Xbox One.
- We flip open the top case, granting us a peek at the ~~mines of Moria~~ dark chambers within.
- While our first peek doesn't reveal much, we are ready to venture through shadow and circuit...

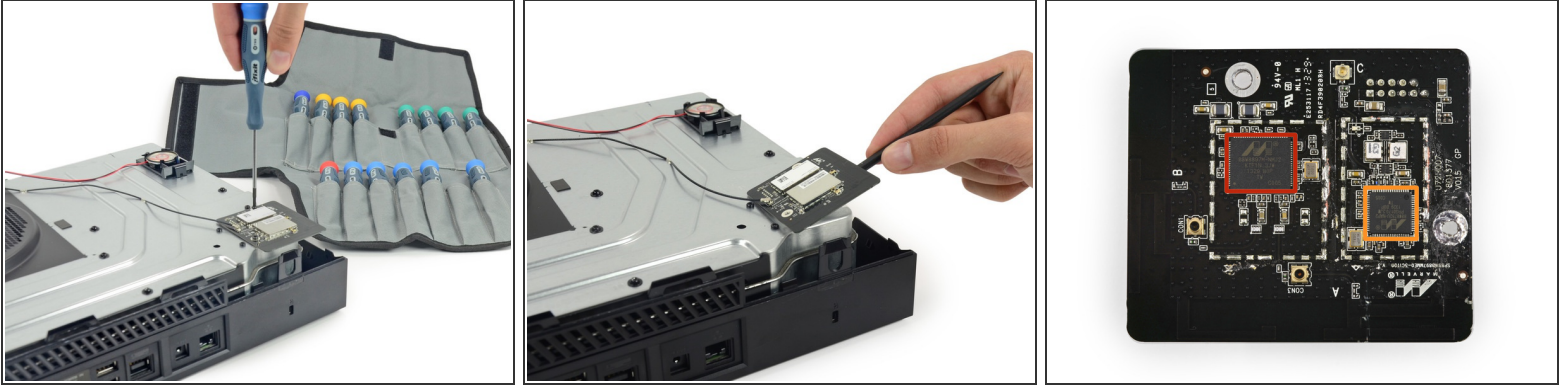
Step 9

- Our [Pro Tech Screwdriver Set](#) is almost as anxious to get into this console as we are.
- The Pro Tech set was much easier to get through customs than our [backup opening tools](#).
- While we're not sure how they stand up against orcs, our screwdrivers are awesome for removing the small screws holding the Wi-Fi board in place.
- A quick wave of our spudger, and the Wi-Fi board is out and ready for inspection.
 - Marvell Avastar [88W8897](#) 2x2 MIMO Wi-Fi Combination Radio Chip Supports 802.11ac, NFC, Bluetooth and Wireless Display
 - Marvell Avastar [88W8782U](#) WLAN SOC w/USB 2.0 Interface Support

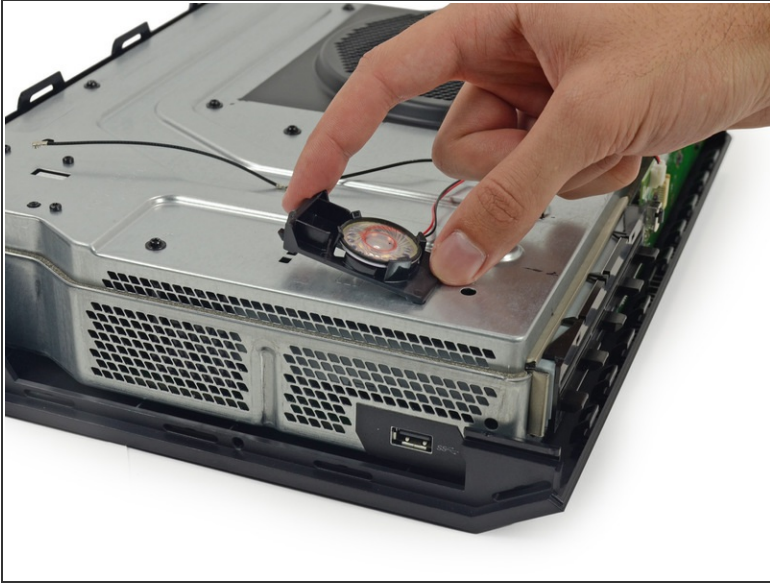
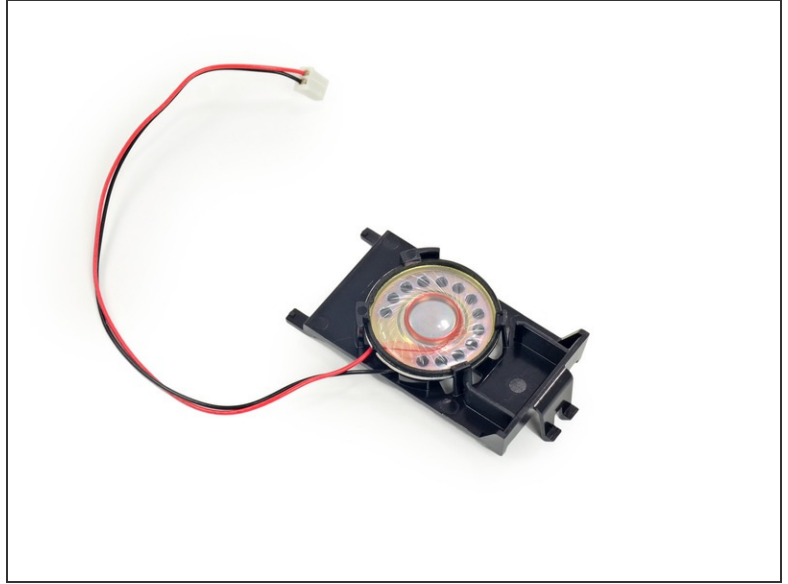
Step 10

- This is interesting. And by interesting we mean unique. We've uncovered a speaker inside the Xbox One. Or it could be an early prototype of an arc reactor. Probably a speaker.
- We're happy that this speaker is held in place with a simple plastic bracket—no tools required.

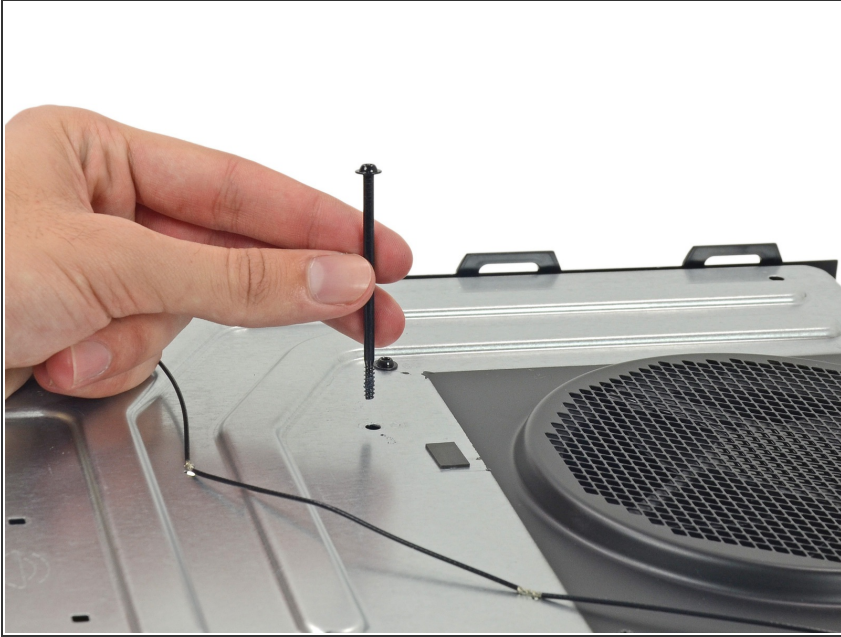
Step 11

- There are eight 64 mm T9 Torx screws securing the upper metal shield to the chassis.
- ⓘ That is just over two-and-a-half inches of threaded fun!
- Game consoles are one place where we haven't seen the smaller, lighter, thinner trend taken to extremes—and we're okay with that. We like a device with a little meat on its bones, if it means finding standard fasteners like these screws—a win for repairability.
- ⓘ Small, light, and thin **can** be [repairable](#) too! We've [seen it](#) happen.

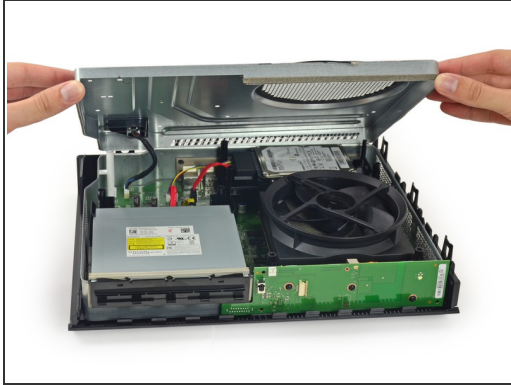
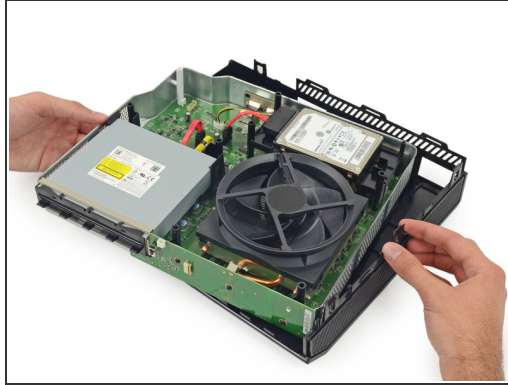
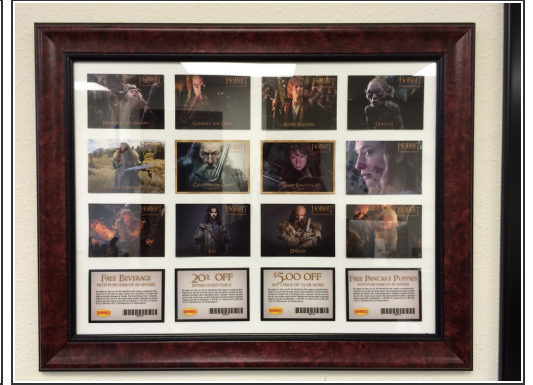
Step 12

- This is our first real glimpse inside the Xbox One.
- Well, that was easy. The entire Xbox One assembly simply lifts off from the lower case.
 - We appreciate a mystery, wrapped in an enigma, hidden inside a [hobbit hole](#) as much as the next person, but for repair purposes, it's nice when things are a little more straightforward.
 - How much do we care about the Hobbit Hole breakfast at Denny's? Oh, you know...

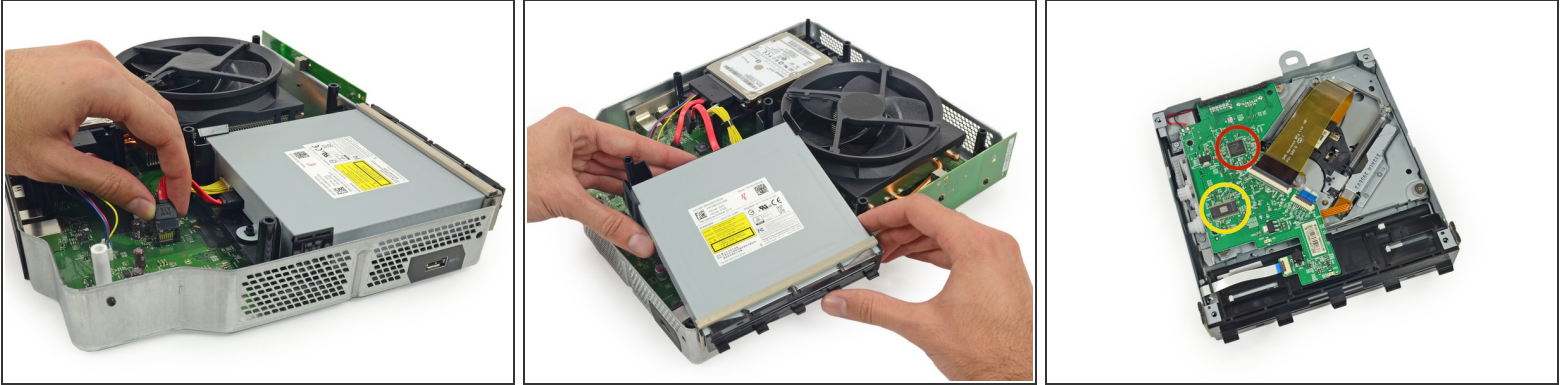
Step 13

- In another win for repairability, the Blu-ray/DVD drive is connected to the motherboard via a SATA data connector.
- While we are tempted to re-watch the entire LOTR trilogy on Blu-ray, our own quest to destroy the One Xbox in the fires of the teardown table is more dire.
- We take a look at the underside of the optical drive, finding a few ICs and a large ribbon cable:
 - Microsoft MS0DDDSPB1 1326-BTSL ATNGS501
 - Texas Instruments 37T AVY7

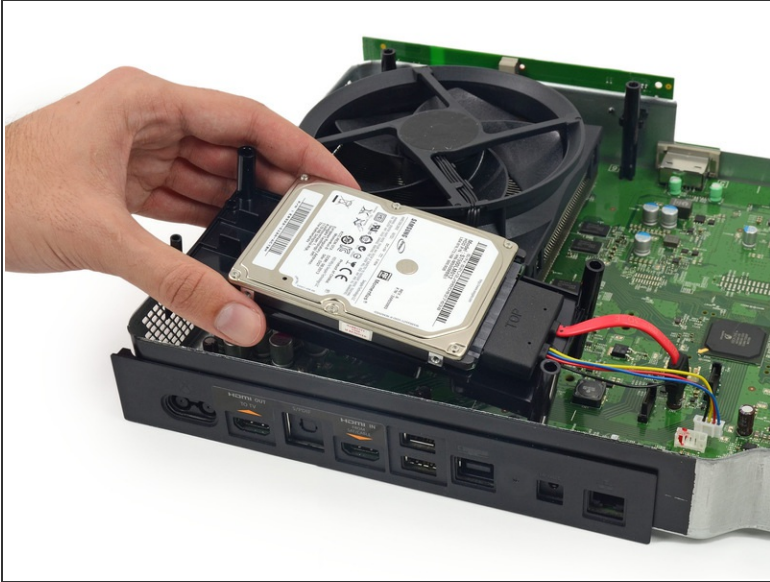
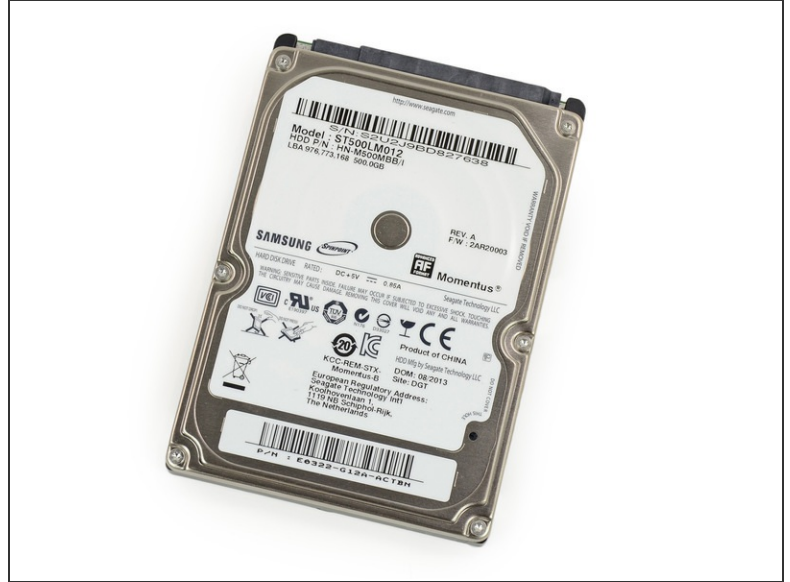
Step 14

- Unfortunately, the Xbox One doesn't *officially* feature a replaceable hard drive—but then, we're not much for playing by the rules. Out it comes.
 - Bad news: replacing the hard drive requires voiding the warranty. Good news: it's a standard 2.5 inch SATA II drive. Sad news, the Xbox One doesn't support unformatted hard drives.
 - Inside our Xbox One, we find a Samsung Spinpoint M8 [ST500LM012](#) 500 GB 5400 RPM with 8MB Cache SATA II 3.0Gb/s hard drive.
- ① [Newegg](#) seems to have favorable reviews of this drive.

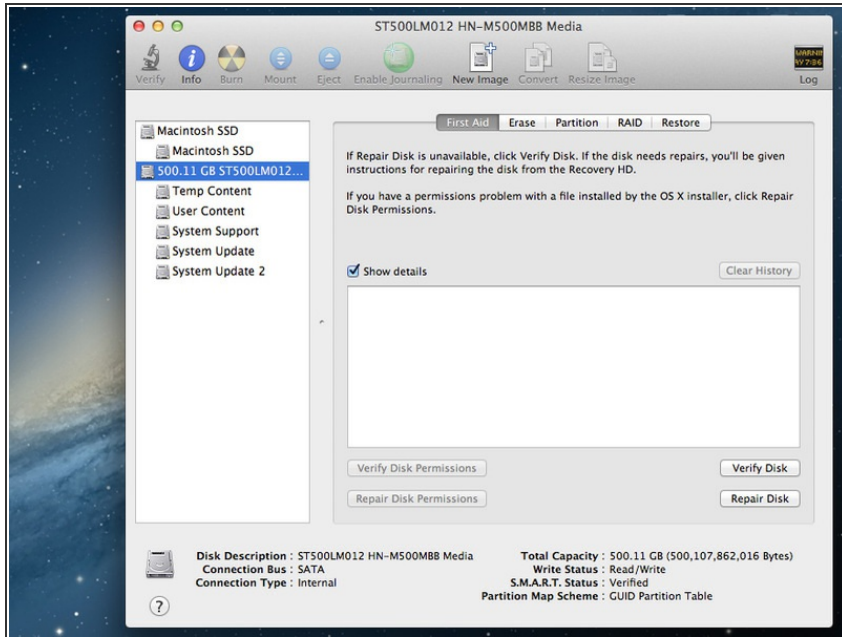
Step 15

- **Teardown update:** We tossed the One's hard drive into one of the tech writers' [secondary hard drive bays](#). We found **five** NTFS partitions:
 - *Temp Content*: 44 GB capacity, 27.1GB available (in an Xbox that we never turned on).
 - *User Content*: 391.9 GB capacity, none used.
 - *System Support*: 42.9 GB capacity, 34.1 GB available.
 - *System Update*: 12.8 GB capacity, 11.8 GB available.
 - *System Update 2*: 7.52 GB capacity, 7.47 GB available.
- Sadly, we were not able to go the other way -- we didn't have a spare hard drive (in New Zealand) to put into the Xbox One. So that will have to wait for another day!

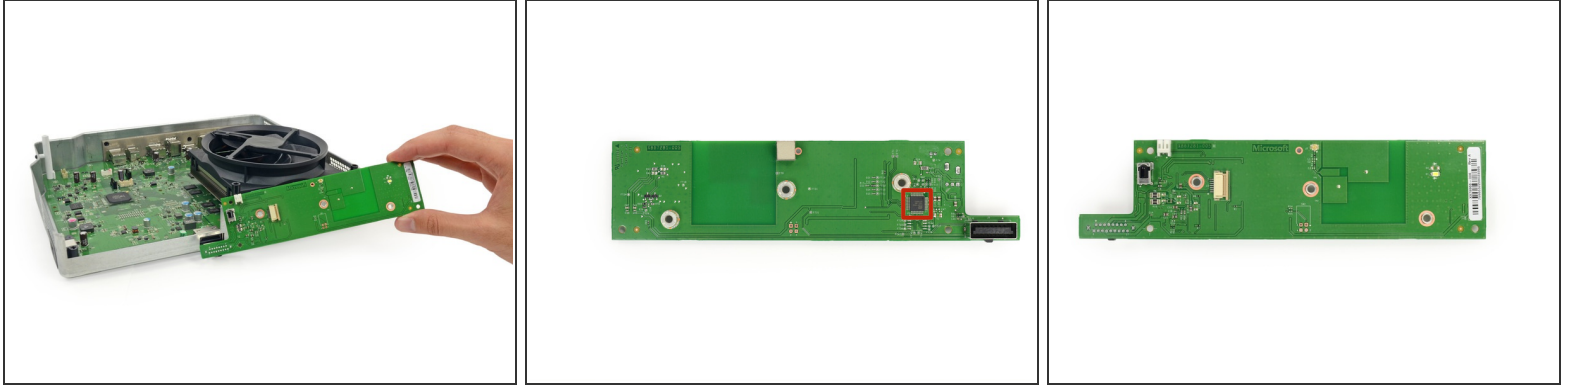
Step 16

- The RF Module board detaches outward from the lower case.
- The back of the RF Module board features one lone IC from Info Storage Devices labeled 9160F1MS03 1327 2317B057. We believe this is an Audio User Interface chip from [Nuvoton](#).

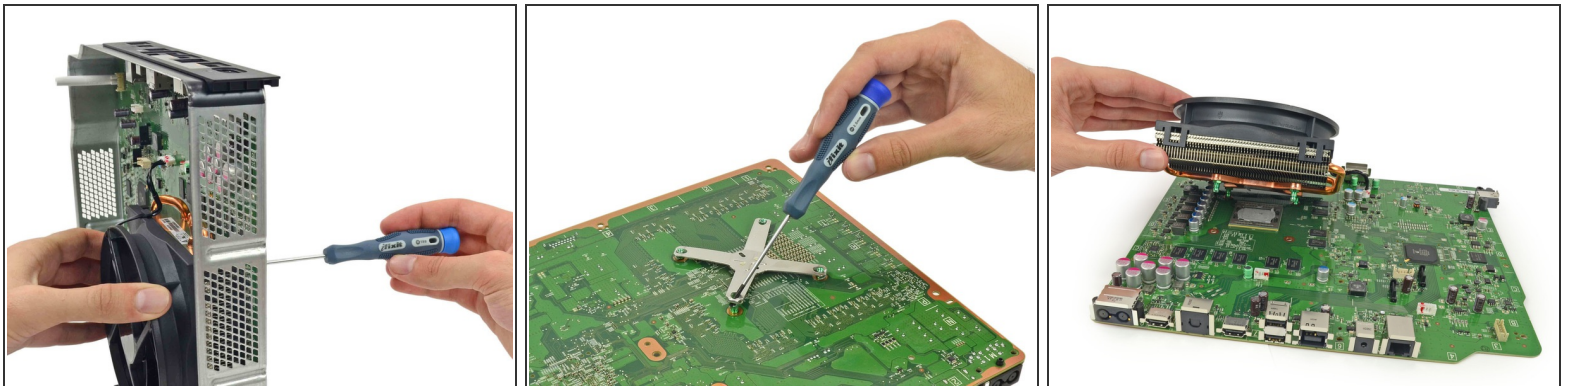
Step 17

- "X" marks the spot. The heat sink/fan assembly is secured to the motherboard with a few T9 Torx screws.
- ⓘ After the infamous [red ring of death](#), we're not surprised to see a beefy cooling system on this Xbox.

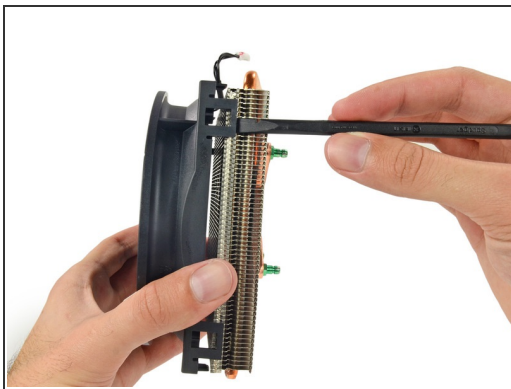
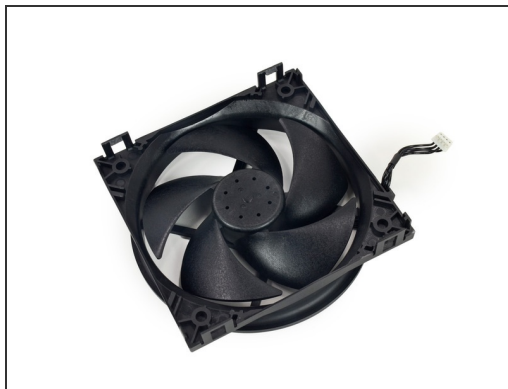
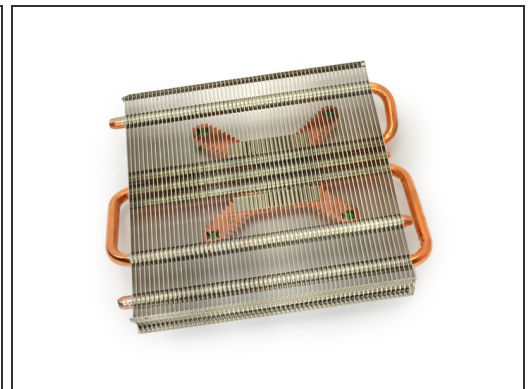
Step 19

- We're happy to report that, should your new Xbox One have cooling issues, replacing the fan or heat sink is easy-breezy.
- All it takes is a simple flick of the spudger to separate the 112 mm diameter fan from the heat sink.
-

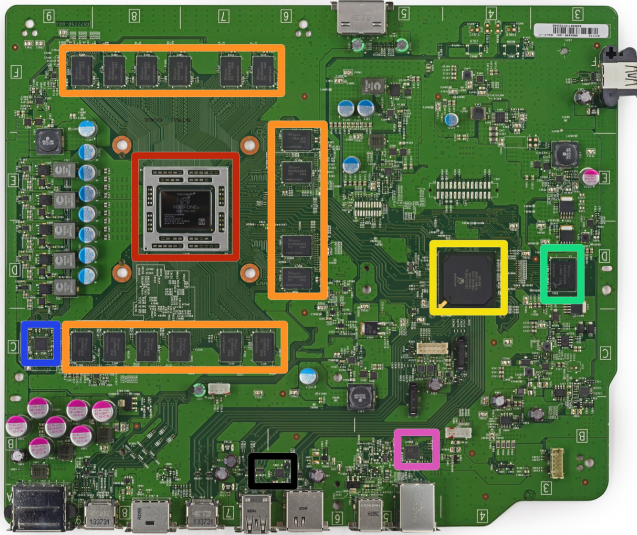
Step 20

- What do our elf eyes see? An army of integrated circuits. The heavy hitters include:
 - X887732-001 DG3001FEG84HR (includes AMD "Jaguar" 8-core CPU + AMD Radeon Graphics GPU)
 - 16x SK Hynix [H5TQ4G63AFR](#) 4 Gb (512 MB) DDR3 SDRAM (total of 16 x 512 MB = 8 GB)
 - X861949-005 T6WD5XBG-0003
 - SK Hynix H26M42003GMR 8 GB eMMC NAND Flash
 - ON Semiconductor NCP4204 GAC1328G Integrated Power Control IC
 - Realtek RTL 8151GNM Ethernet Controller
 - Texas Instruments [TPS2590](#) 3-V to 20-V High Current Load Switch

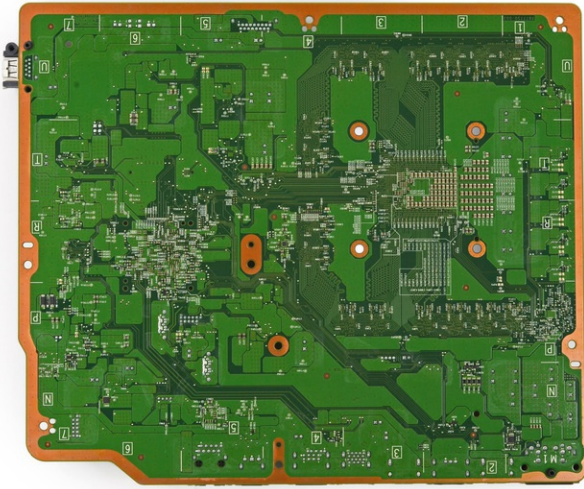
Step 21

- The backside of the motherboard is a glorious, green field, void of any integrated circuits.
- As always, a big thanks to the folks at [Chipworks](#) for helping us determine names of the doodads we found inside the Xbox One!
- If you haven't, already, check out their in-depth [analysis of the PS4!](#)
